LEAD IN DRINKING WATER TESTING REPORT

Conducted at:
Horace Mann Community School
25 W 38th Street
Bayonne, New Jersey 07002

REPORT DATE: October 25, 2022

MES PROJECT NO.: 22-04448

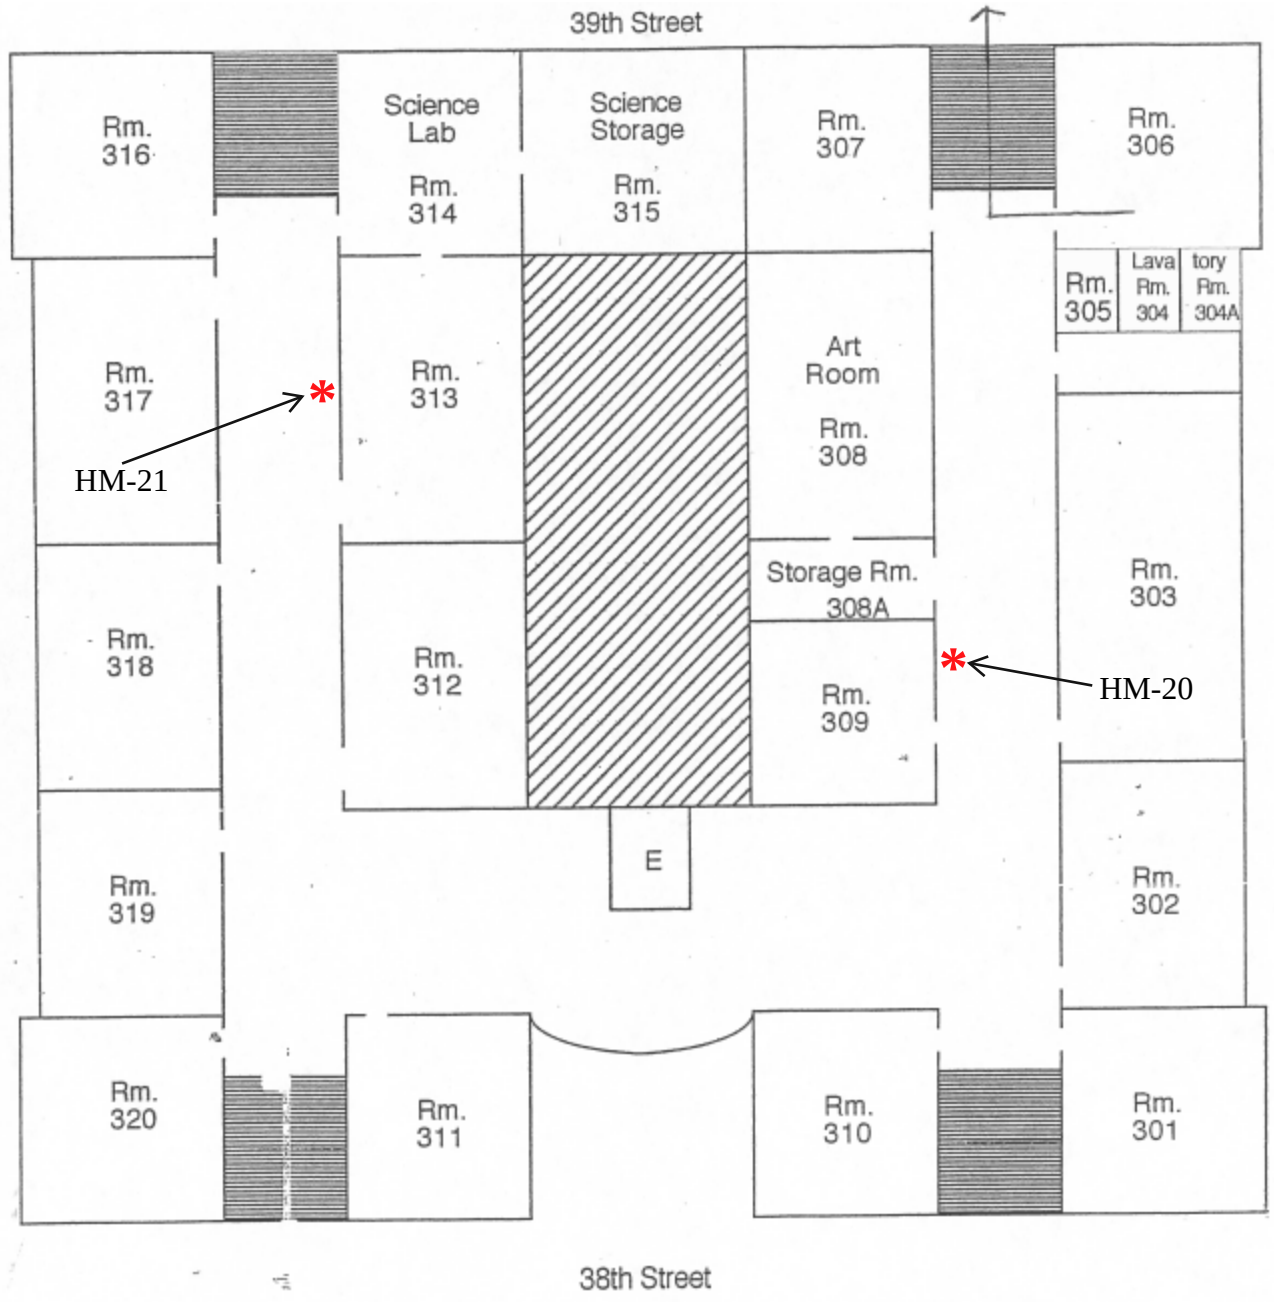
Project: Bayonne Bayonne Board of Education Horace Mann Community School Lead in Drinking Water	Drawing Title: Horace Mann Community School Second Floor Sample Locations		Date: 09/09/2022
	Note: Not To Scale	MES Project Number: 22-04448

HM-17	**First Draw – Bubbler by Room 204**	**19.5**	**Fail**	Pass
HM-18	First Draw – Bubbler by Room 217	13.1	Pass	Pass
HM-19	First Draw – Bubbler by 213	8.8	Pass	Pass
HM-20	**First Draw – Bubbler by 303**	**16.3**	**Fail**	Pass

McCabe recommends discontinued usage of the following outlets which resulted in failed results until additional samples can be collected and analyzed and a permanent solution can be recommended:

- **Bubbler by Room 204**
- **Bubbler by Room 303**
